Transmission filter before cleaning. Pump whine, transmission service required codes P1618 and P0740. Delay and slipping in reverse and drive when cold. Pump starved of fluid due to clogged filter.

Transmission mileage and service history; dealer installed remanufactured transmission in 2009 and now with 105K miles of use, 4 drain and refills since installed, magnefine inline filter installed since first installed, changed 3 times. Primary internal filter still clogged as shown. Transmission working fine before signs of filter clogging up, fluid condition excellent since installation of transmission. 2001 V70 T5 200K miles, 2<sup>nd</sup> remanufactured installed at 95K, 1<sup>st</sup> remanufactured installed at 75K, starting whining like pump was clogged at 95K, dealer replaced under warranty

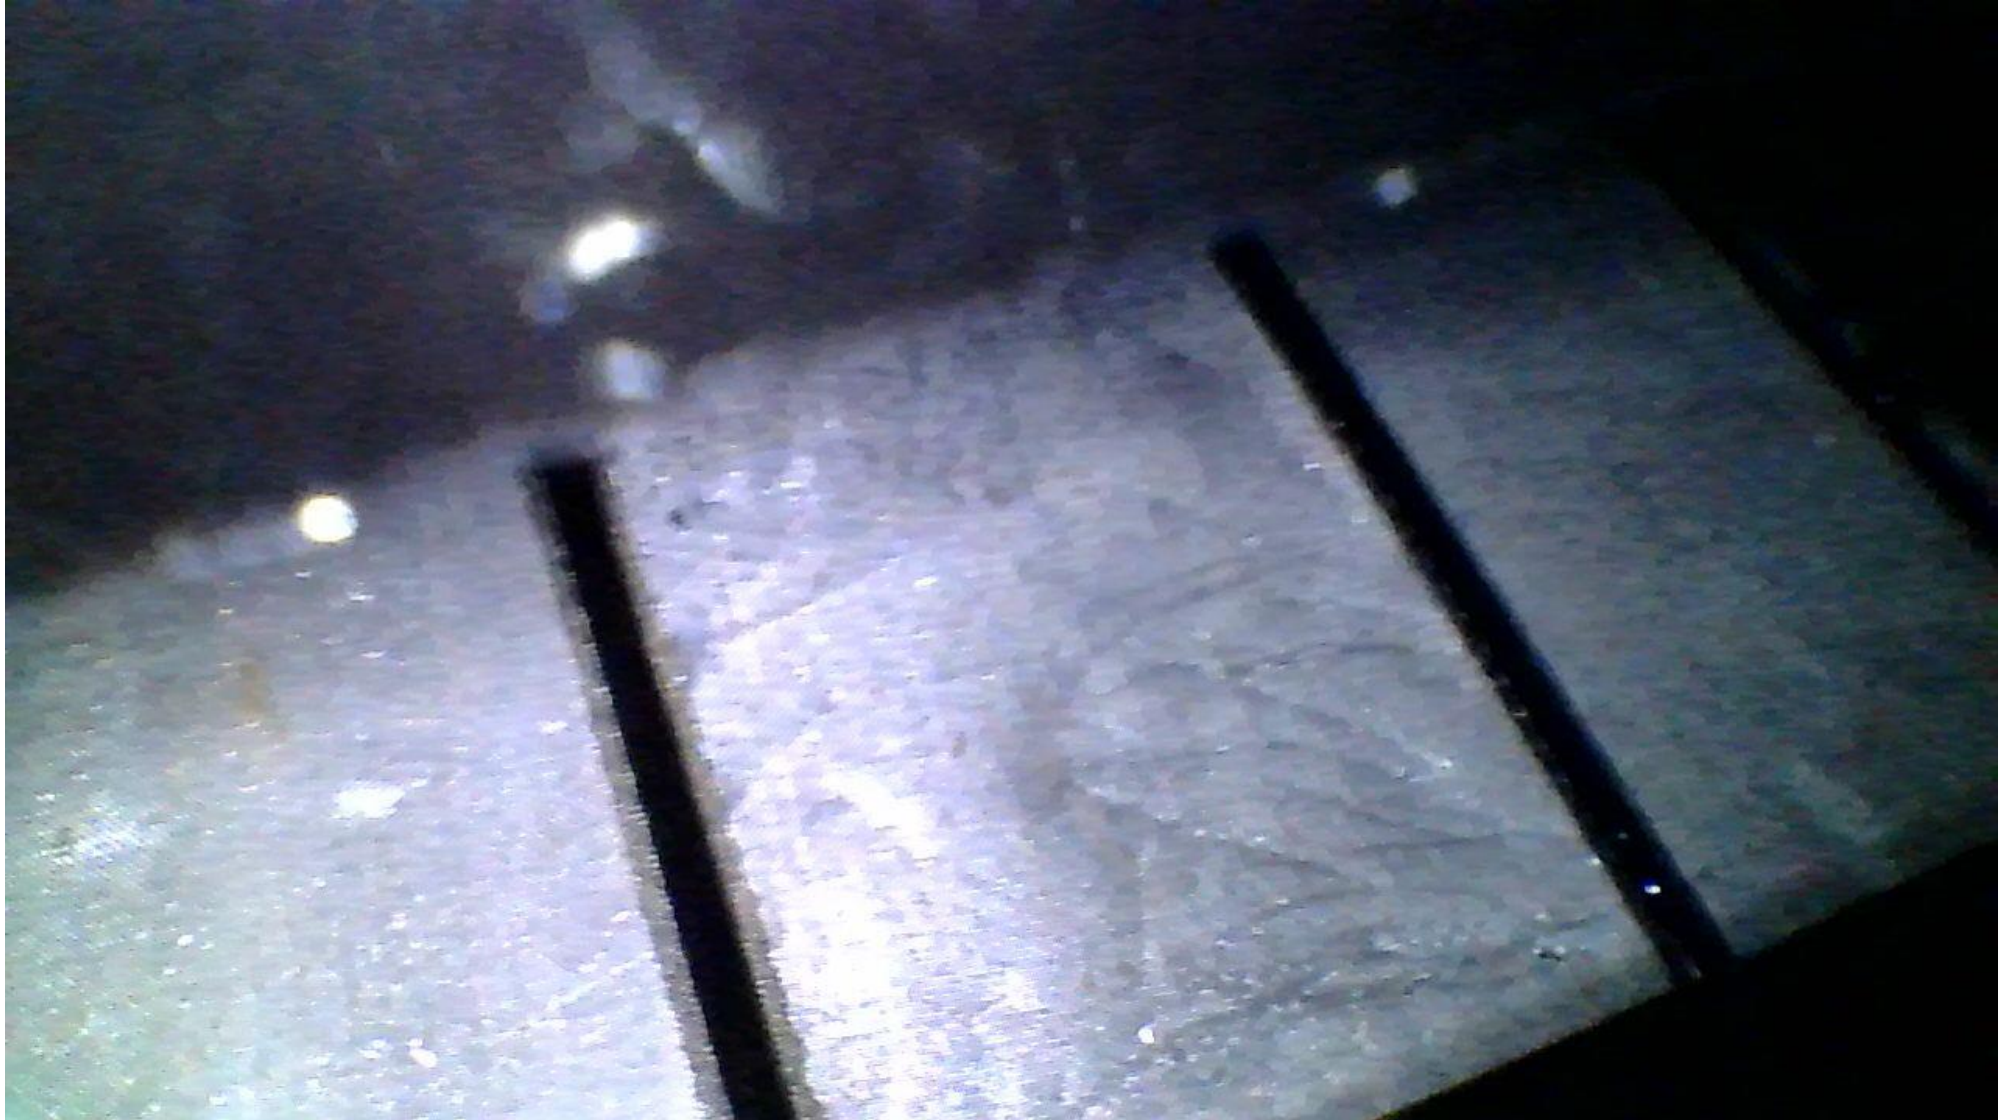
Filter mesh appears to be nylon, particles and film on underside is tough to remove, direct force spray of carb cleaner works well but need high flow and close contact for good cleaning.

Filter mesh after first cleaning with carb cleaner spray through newly added drain hole under inlet port of filter. Area of filter mesh cleaned was just the area easily accessed through the intake port of the filter, approximately  $\frac{1}{4}$  the area of the total filter mesh. Deeper inside the filter not clean as well during first cleaning. Transmission pump and shifting were fine after cleaning this amount of the filter area and no pump wine. Second cleaning planned to clean a larger area of the filter mesh.

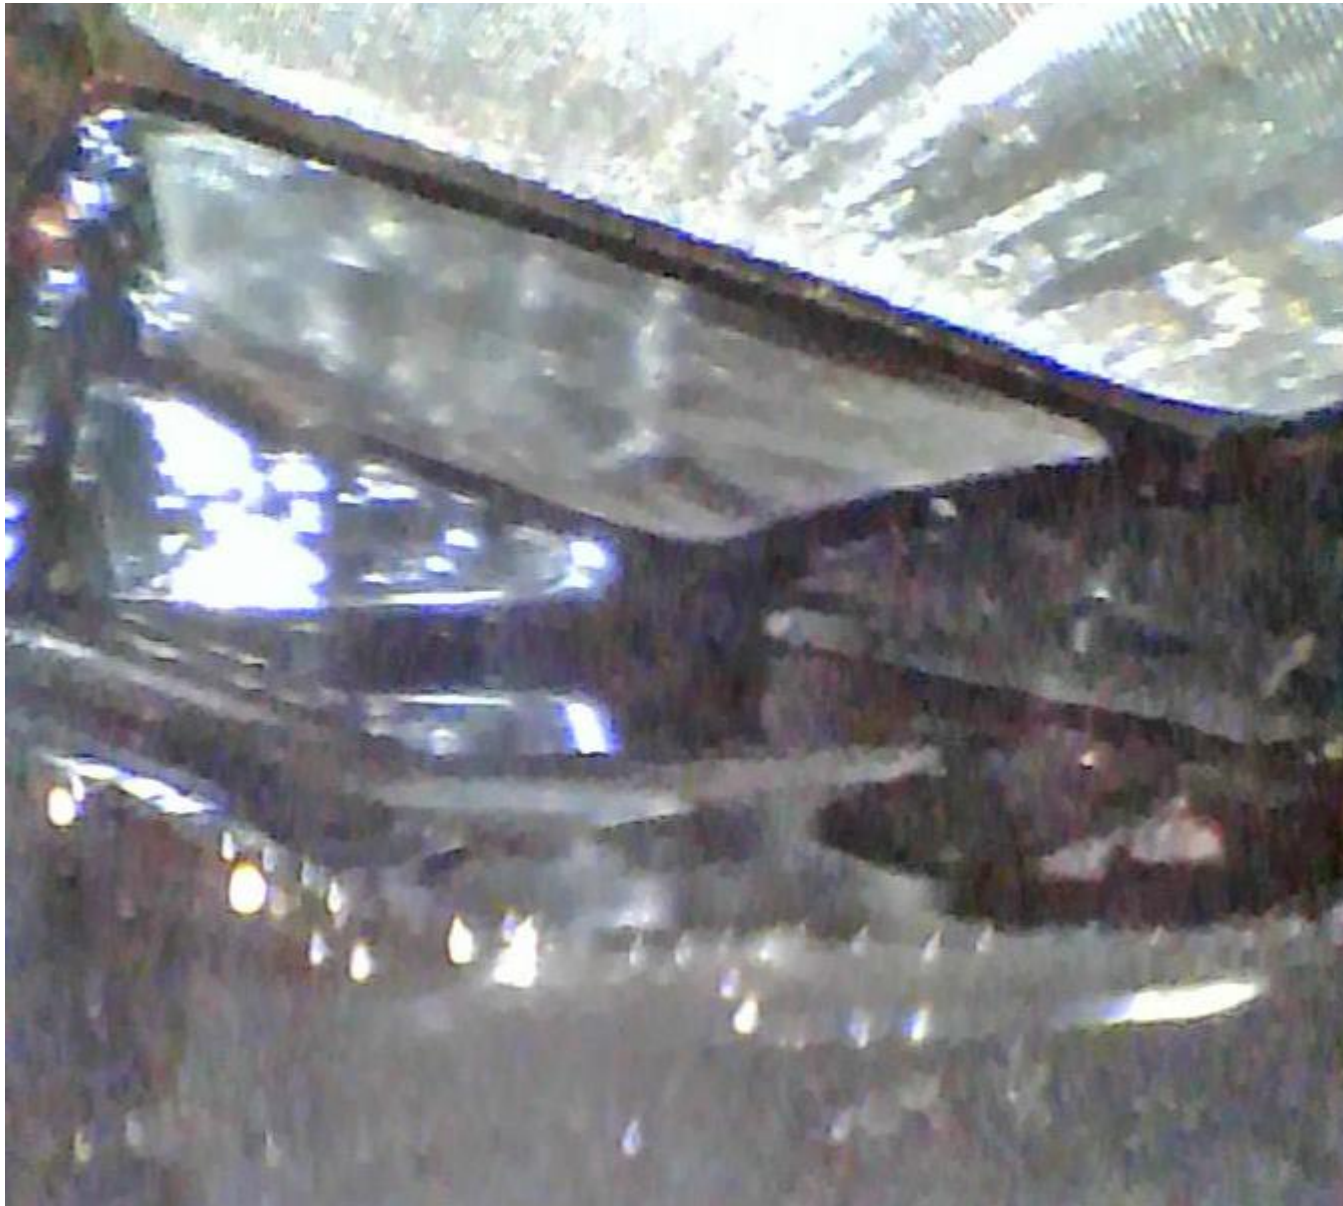
Inner part of filter and after cleaning with bottle brush and carb cleaner with hose extension. Deeper area of filter mesh is out of focus but it is much cleaner than before. I was able to clean out a significant amount of particles from a greater percentage of filter mesh area. Photo from side camera of endoscope looking across bottom side of filter mesh. Although the filter mesh does take a forceful direct spray or brushing to clean well the particles do come off and it appears the mesh is very clean, I didn't see particles still trapped in the mesh.

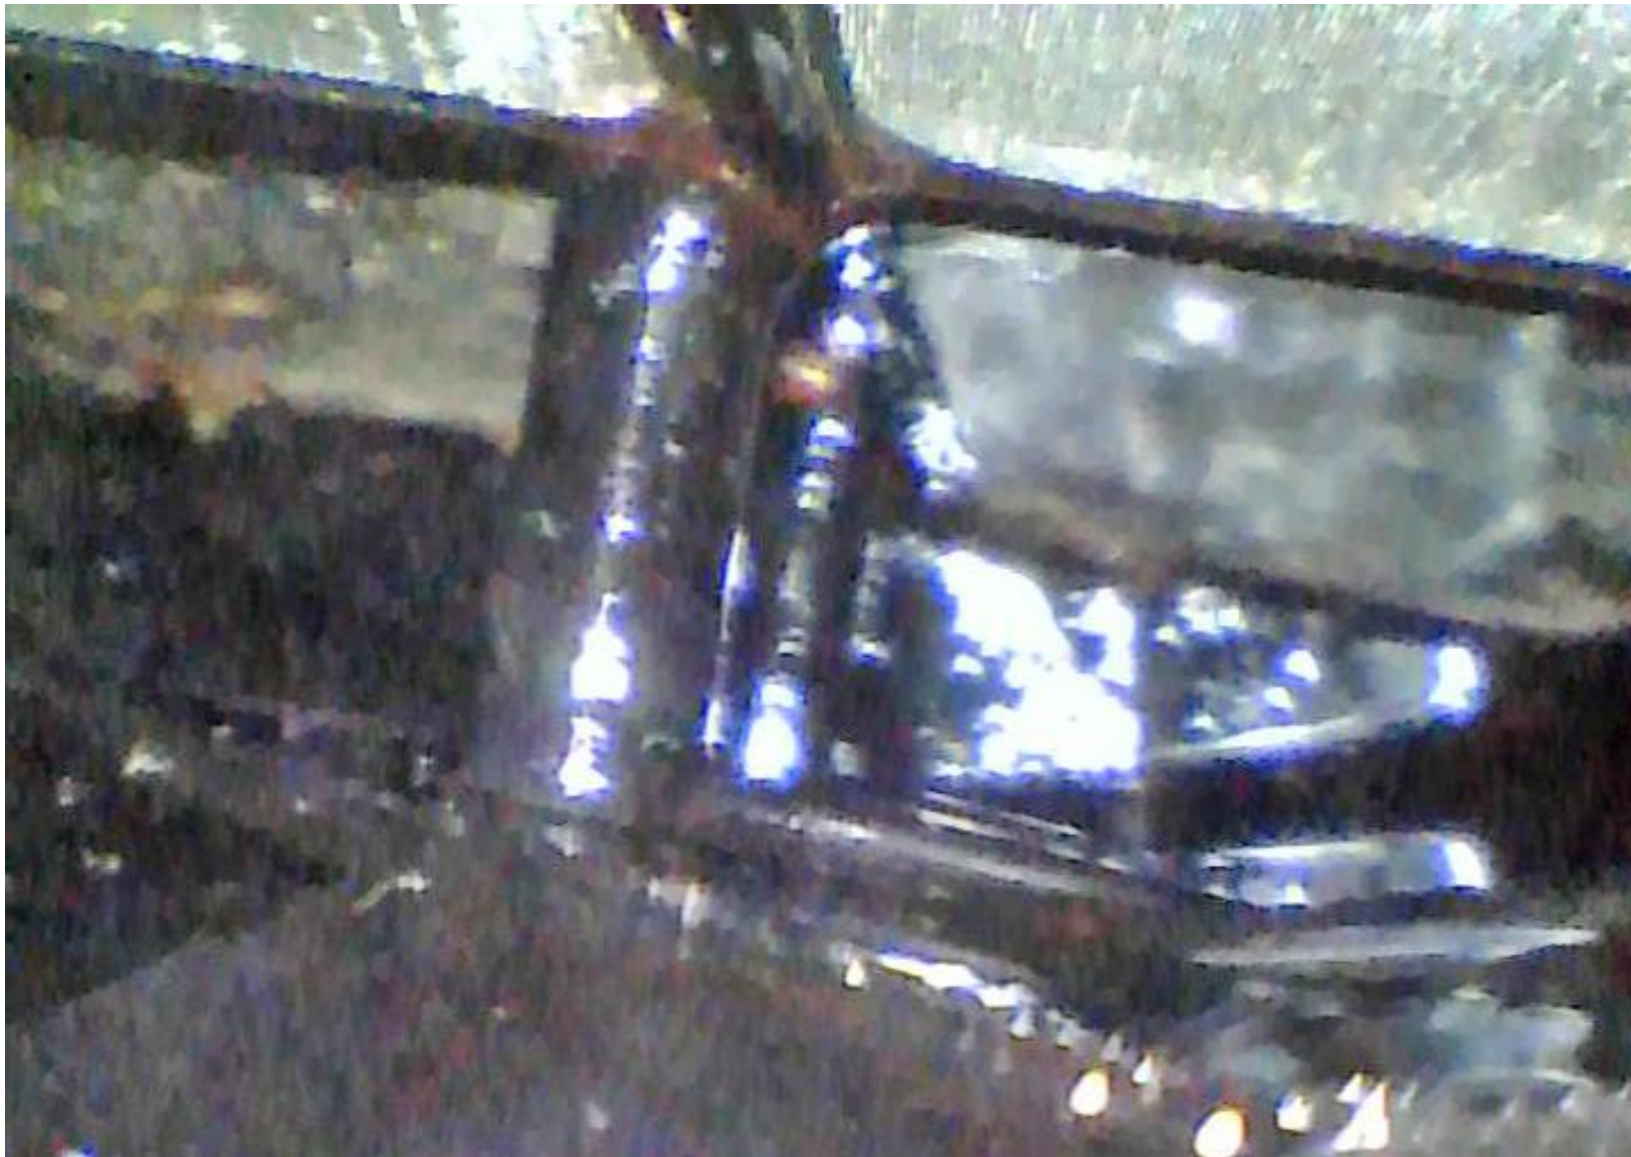
Another photo of inner part of filter after cleaning with brush and brake cleaner with hose extension. Note the left back area, could not get the brush on the other side of the post so this area wasn't cleaned as well but much better than before. The film on the filter mesh is tough to remove so the brush or direct force of carb spray is needed to clean well.

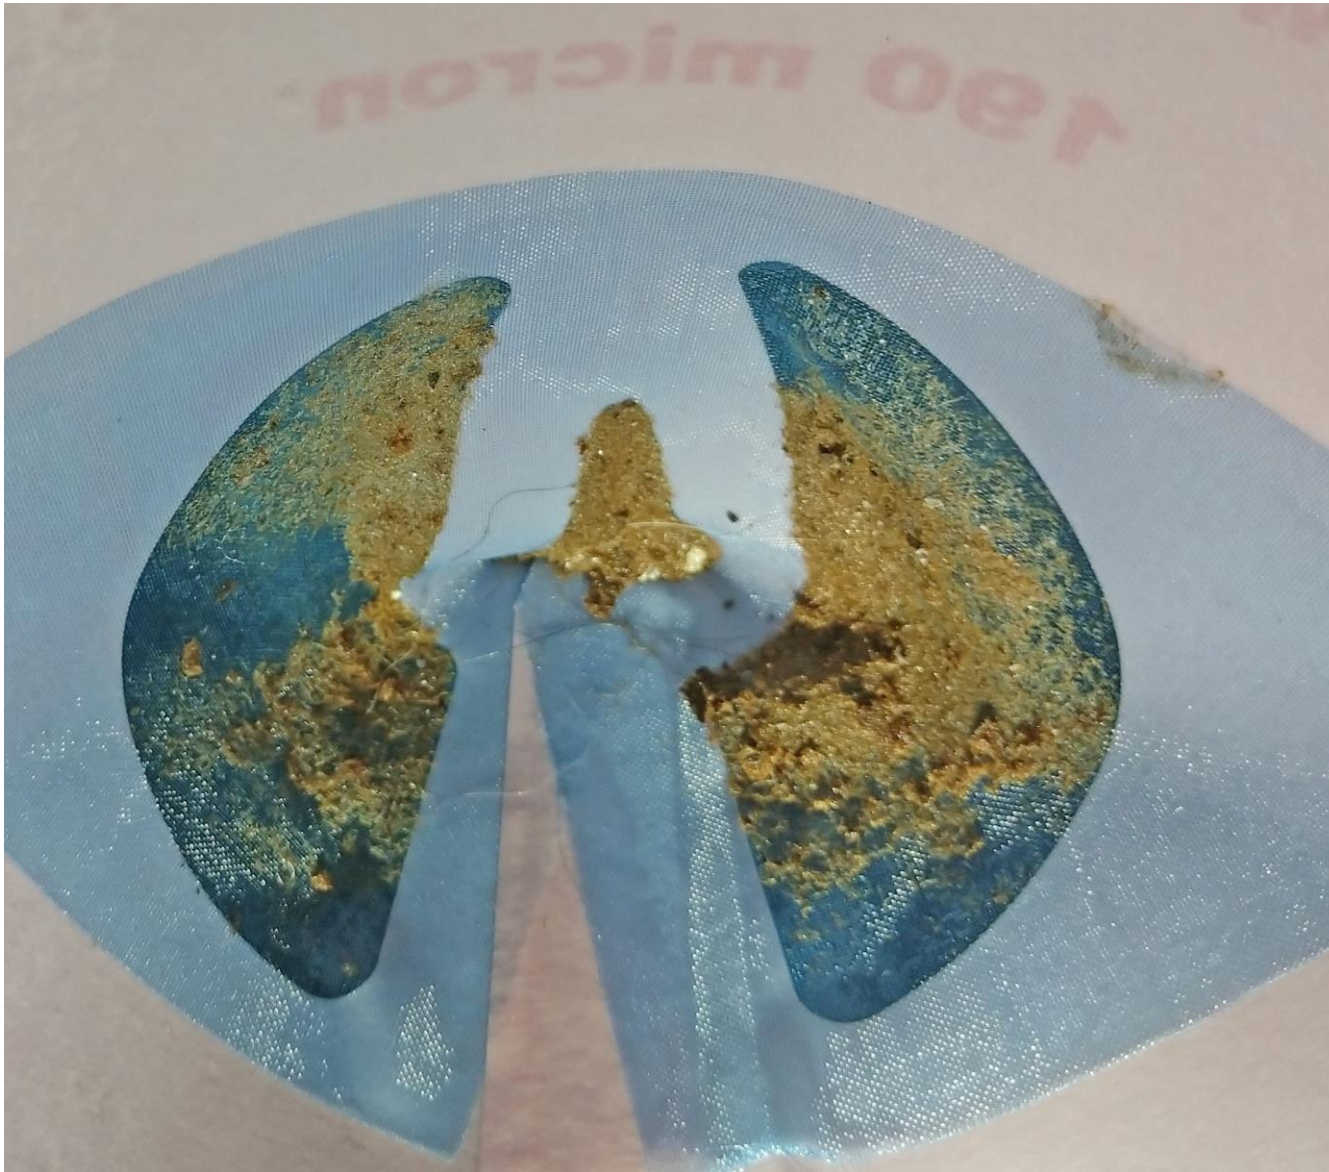
Here's what I was able to clean out with the second cleaning deeper inside the filter and with the bottle brush and brake cleaner with hose extension. Filtered the brake cleaner fluid that drained out of the transmission through a paint filter.

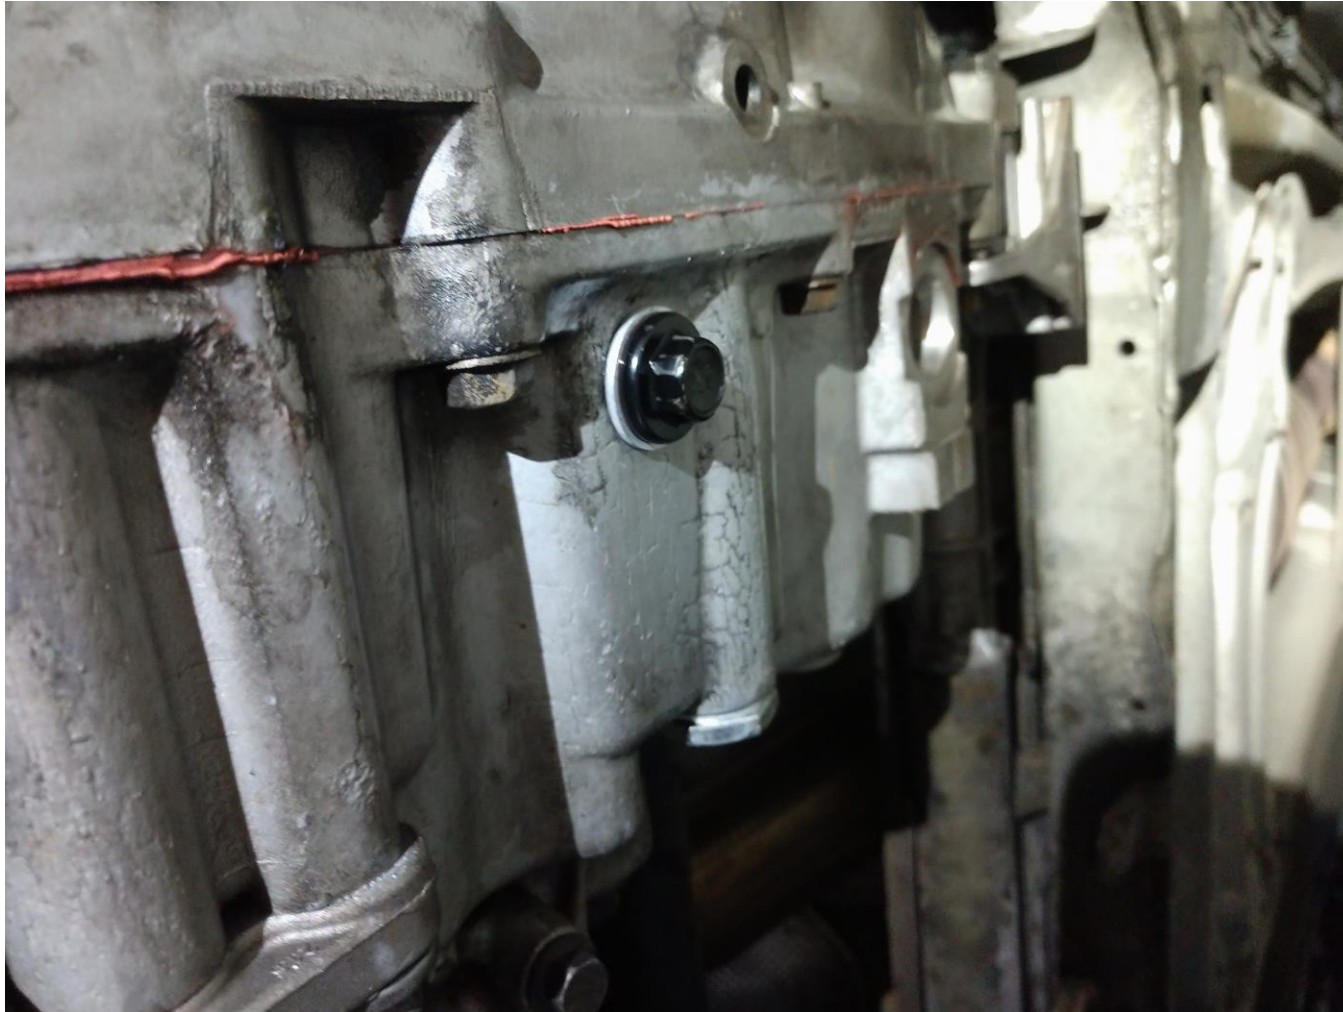
14mm X 1.25 drain plug, used spark plug size tap, finer threads since case is thin. Had problems with a leak because case area around plug is not a machined flat surface. Used 18mm sealing washer and put an o-ring in the gap area between the 14mm plug and sealing ring, which stopped the leak.

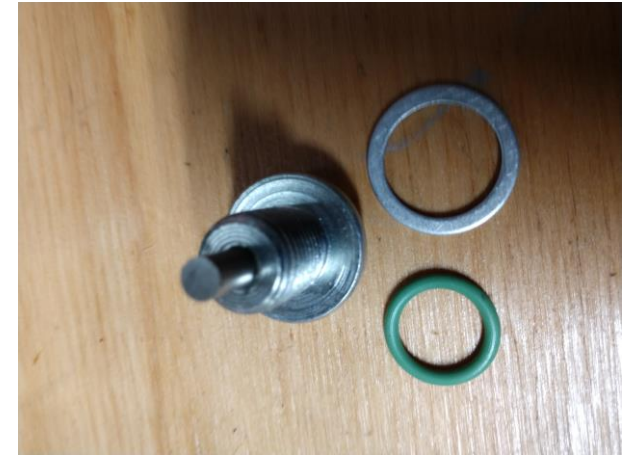
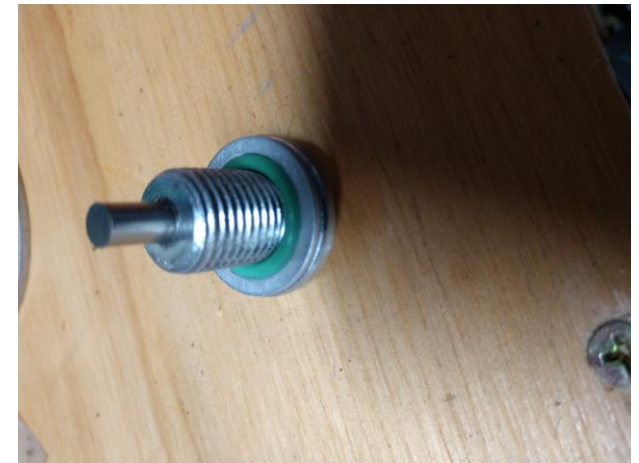
Spark plug size threads has the advantage of insert type repair kits if the threads in the case ever strip. Case is very thin in this location, only 3 or 4 threads so care must be taken when tightening drain plug.

14 mm drain plug 18mm ID sealing washer, 2mm X 13mm ID o-ring or 11/16 in. OD x 1/2 in. ID x 3/32 in. wall #10 or #42 o-ring  
18mm ID sealing ring is what's used on primary drain plug.

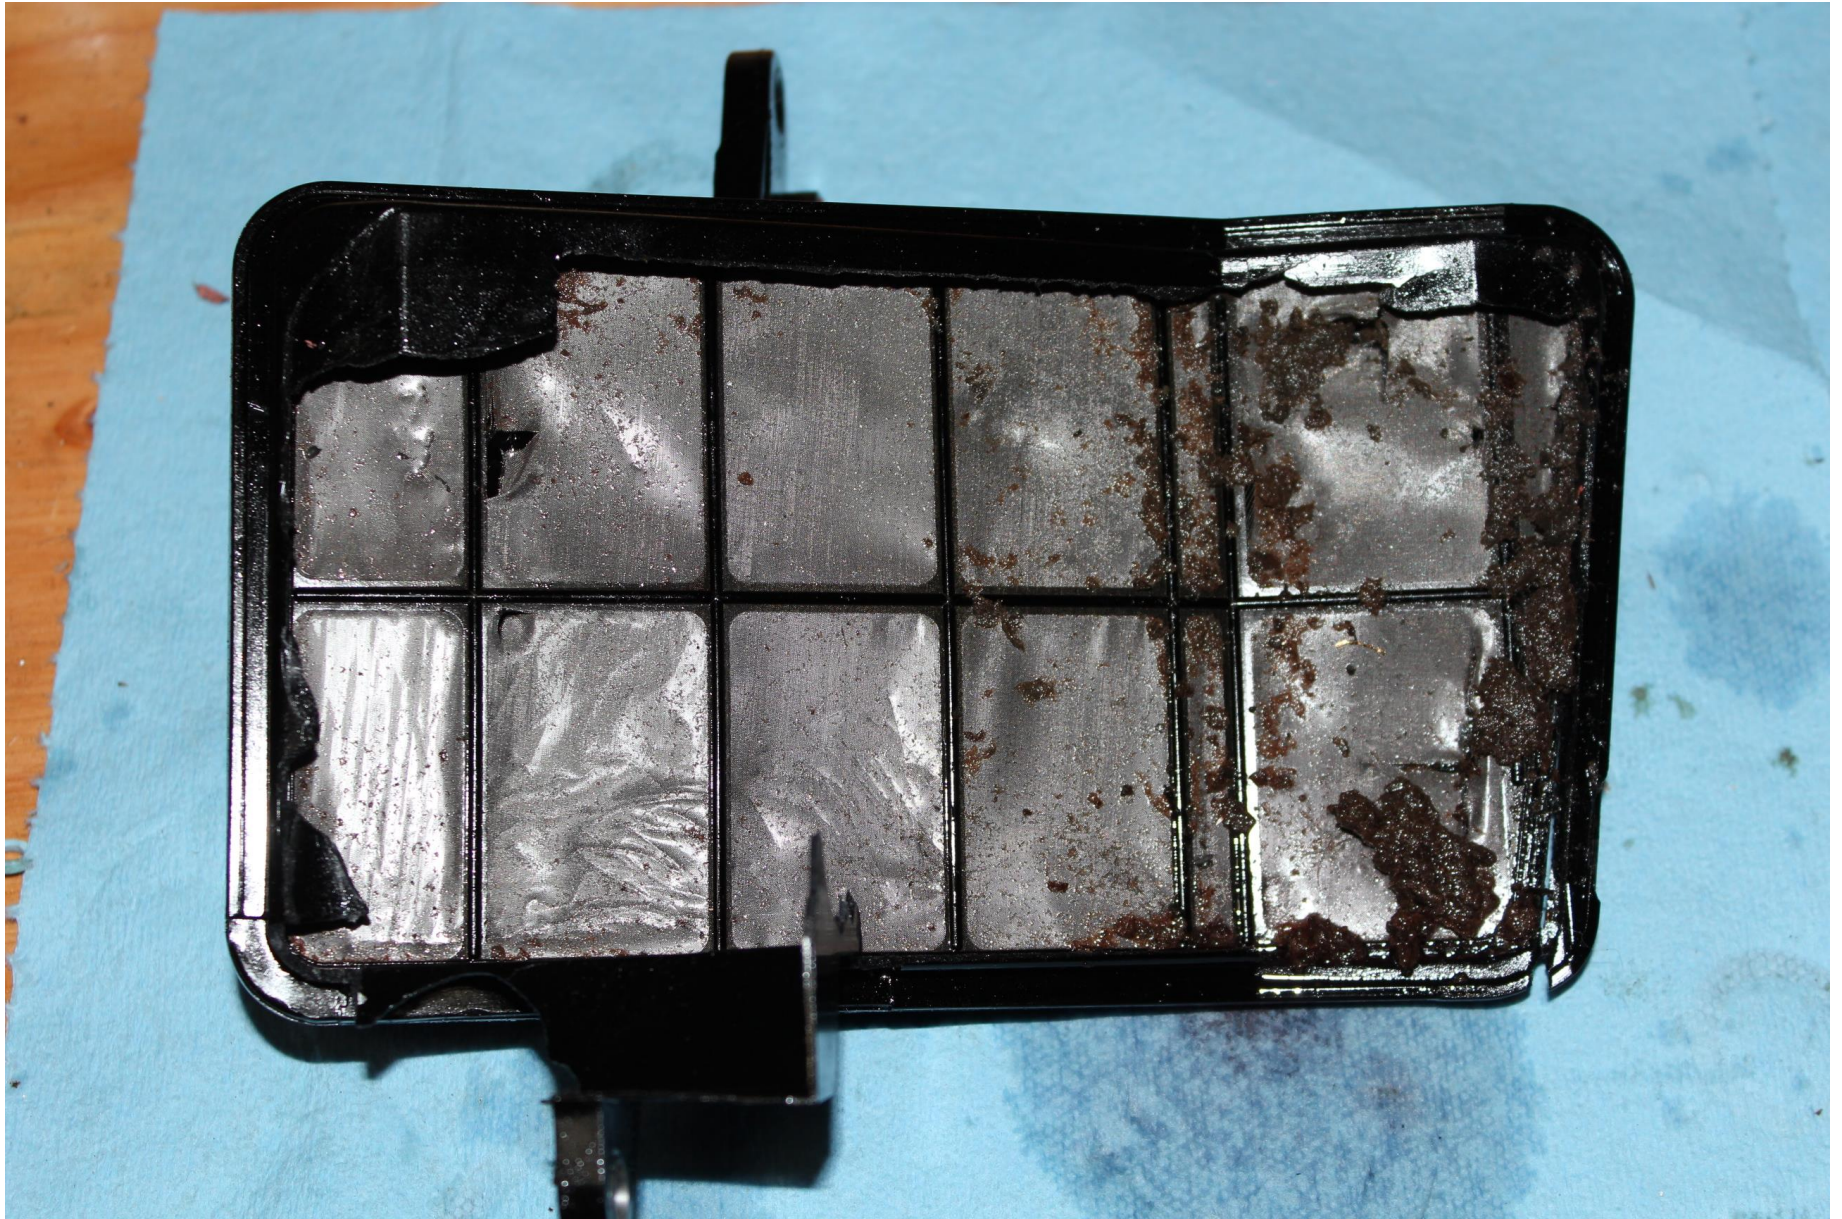
I did eventually rebuild the transmission and this is what the filter looked after cleaning with the brush and brake cleaner through the added drain hole. Overall the cleaning was better than expected, the right side above where there is still build-up is a very narrow part of the filter where brush didn't get to. The holes in the filter mesh wasn't from the cleaning, I punctured it tearing the plastic apart.
