Transmission filter before cleaning. Pump whine, transmission service required codes P1618 and P0740. Delay and slipping in reverse and drive when cold. Pump starved of fluid due to clogged filter.

Transmission mileage and service history; dealer installed remanufactured transmission in 2009 and now with 105K miles of use, 4 drain and refills since installed, magnefine inline filter installed since first installed, changed 3 times. Primary internal filter still clogged as shown. Transmission working fine before signs of filter clogging up, fluid condition excellent since installation of transmission. 2001 V70 T5 200K miles, 2<sup>nd</sup> remanufactured installed at 95K, 1<sup>st</sup> remanufactured installed at 75K, starting whining like pump was clogged at 95K, dealer replaced under warranty

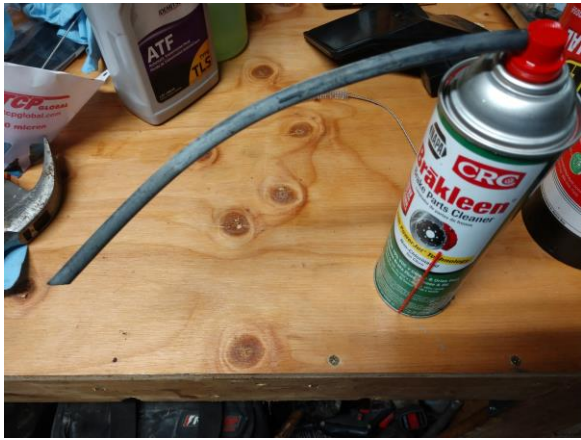
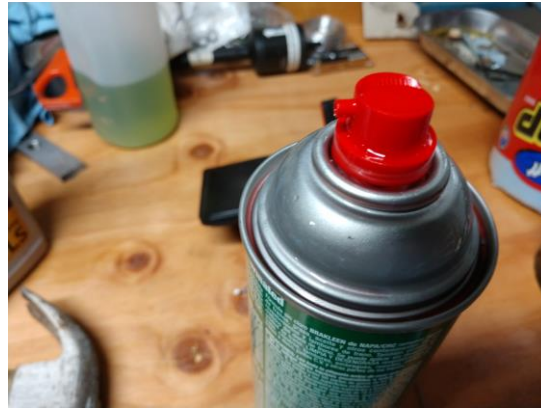
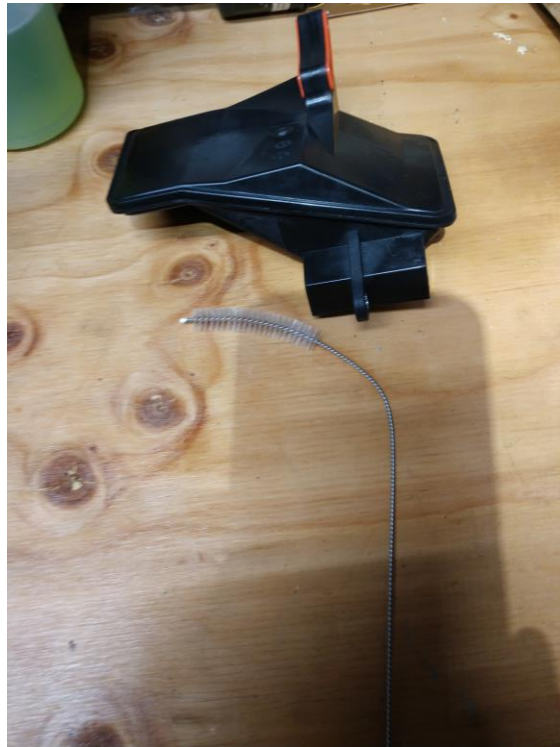
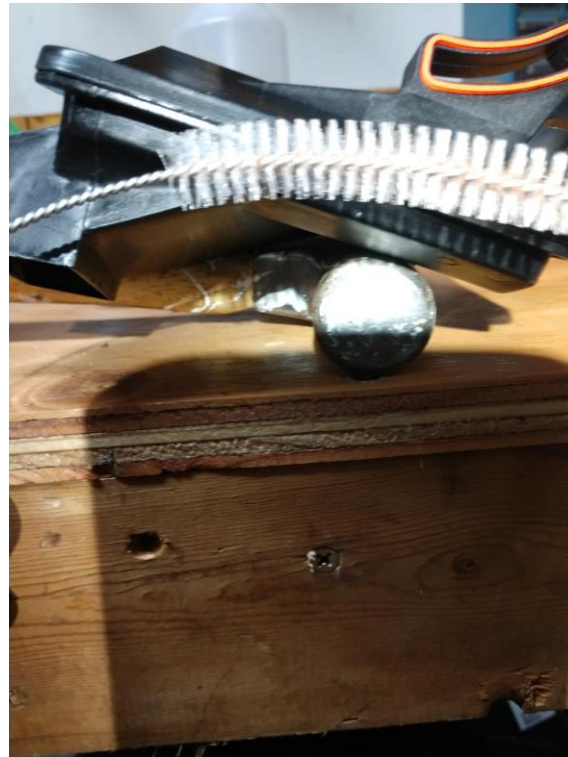
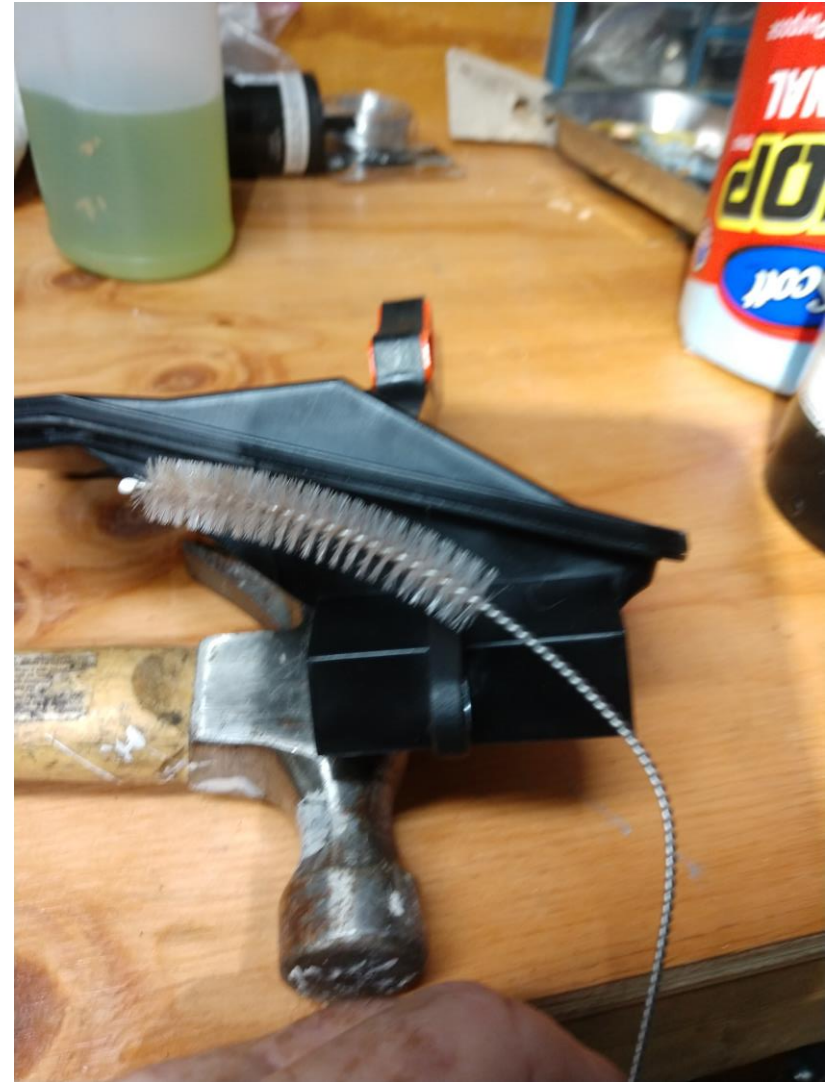
What I found effective to clean deeper inside the filter. Carb cleaner with the type of nozzle shown where you attach a longer tube (3mm ID) and with a larger inside diameter than the red straw for higher flow. Bottle brushes for cleaning straws, 10 to 12 inches long and bent as shown.
